CHRISTCHURCH CITY COUNCIL

GOVERNORS BAY JETTY STRUCTURE CONDITION ASSESSMENT

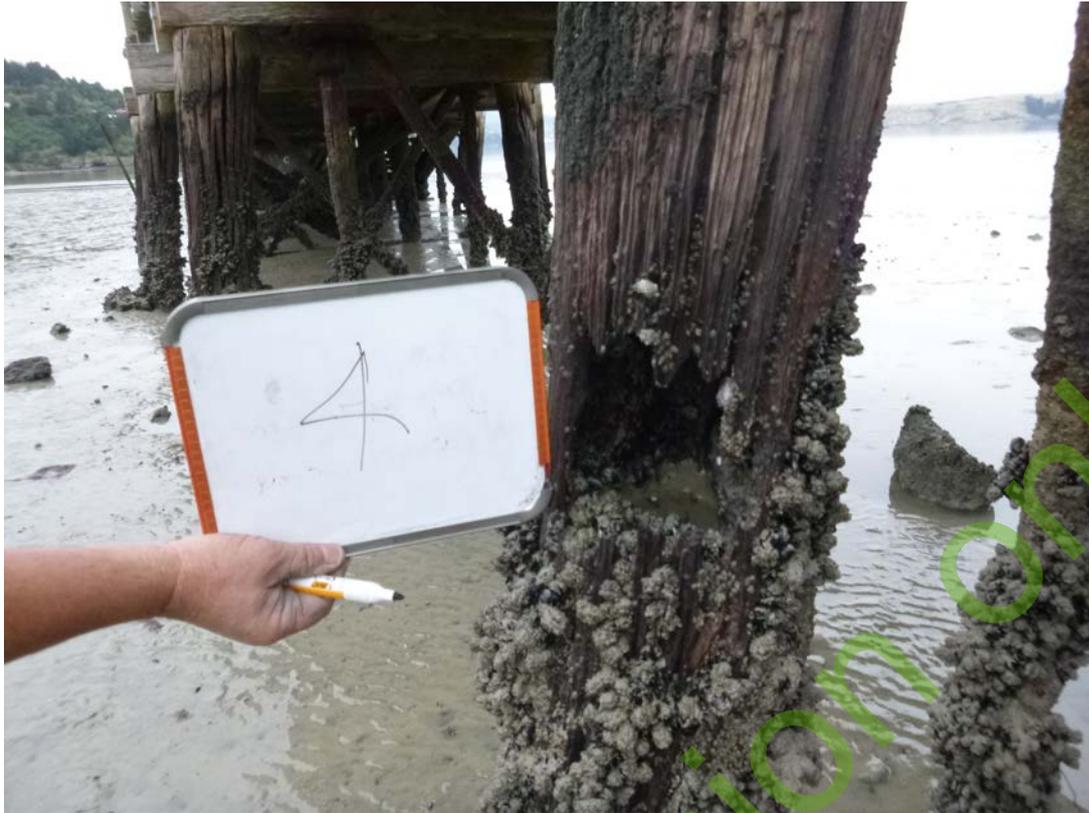
Bent 3		Hardwood round outside steel frame. Necked at bed, 50% cavity 600 up	cap ok, rusted steel cross brace				Hardwood round outside steel frame. Split frm top, cavity thru 100x50 mid height	
Bent 4		Hardwood round outside steel frame. Necked at bed, 75% cavity 600 up	cap ok, rusted steel cross brace				Hardwood round outside steel frame. Necked at bed, 50% cavity 600 up	
			ok	Beams lapped over cap, all bolted to cap 100	ok	90		
Bent 5		Large cavity mid height, 80% wasted, vertical splits to top	cap ok, rusted steel cross brace				Large cavity mid height, 80% wasted, vertical splits to top	
Bent 6		Large cavity mid height, 80% wasted, vertical splits to top, bearing part only	cap ok, rusted steel cross braces broken thru				Large cavity mid height, 80% wasted, vertical splits to top	
			50	100	ok	ok		
Bent 7		Hardwood round with fender post to outside, ok	Diagonal brace wasted at bed level, ? Horiz brace probed 800 below bed				Large cavity wasted 750 above bed, 80%

Northern Pile Bent 4

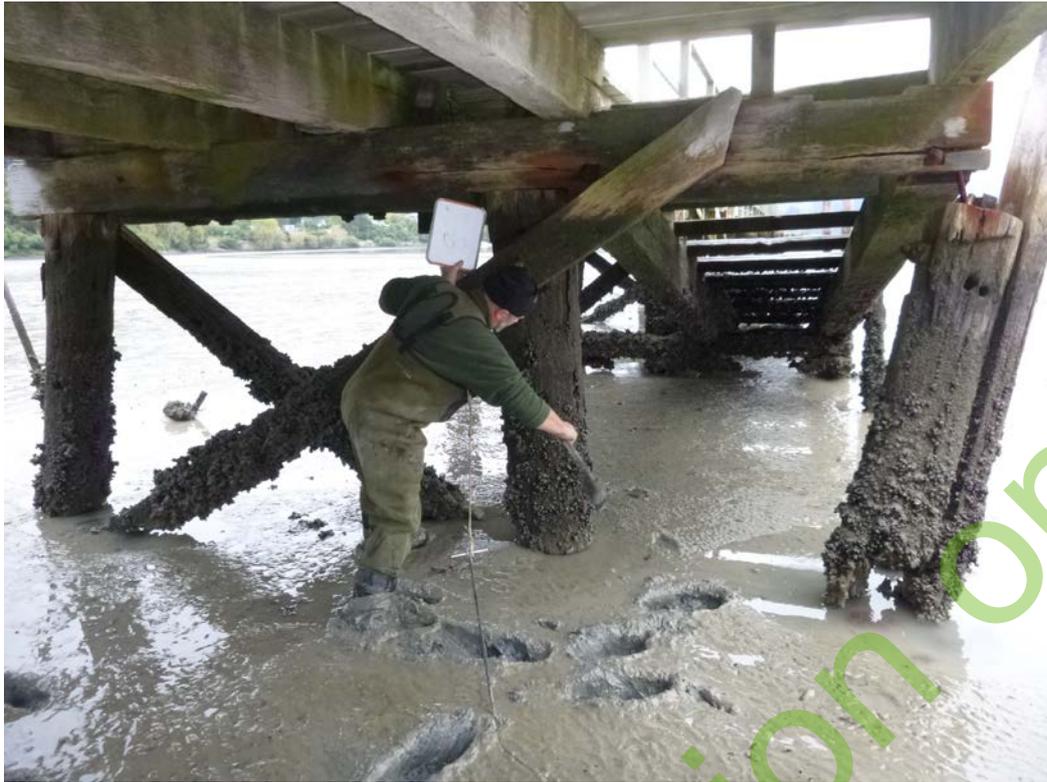
Bent No	S pile	Cap, bracing, corbels (on bent lines)				N pile	Deck
		Beam	Beam	Beam Drilled depth to sound timber	Beam		
Bent 8	Outer pile broken at bed and swinging off stair stringer Pile has 80% cavity at 700 above bed		Cap cantilevers to broken pile, has horiz cracks and reduced to half section			Pile has 4 holes, 80% cavity 700 above bed	
Inshore Landing	inside 300x250 stair stringer split, reduced to half section	ok	80	100+	50		
Bent 9	Short 300sq pile supporting stair, 100x60 slot at bed, fender post 50% wasted at bed	pile 60% wasted at bed	Cap 300x250 ok				Pile 75% cavity at brace connection height
	Steps and stringer need replacing, handrails u/s		100	100+	80	ok	
Bent 10	Pile has hole at mid height, hollow and split up to cap	Start of lower caps, 200x200 corbels and long spans 8m nom	Timber cross brace disconnected, wasted at seabed.	3 corbels need replacement		Pile non viable, large cavity

Outer stair support Bent 8

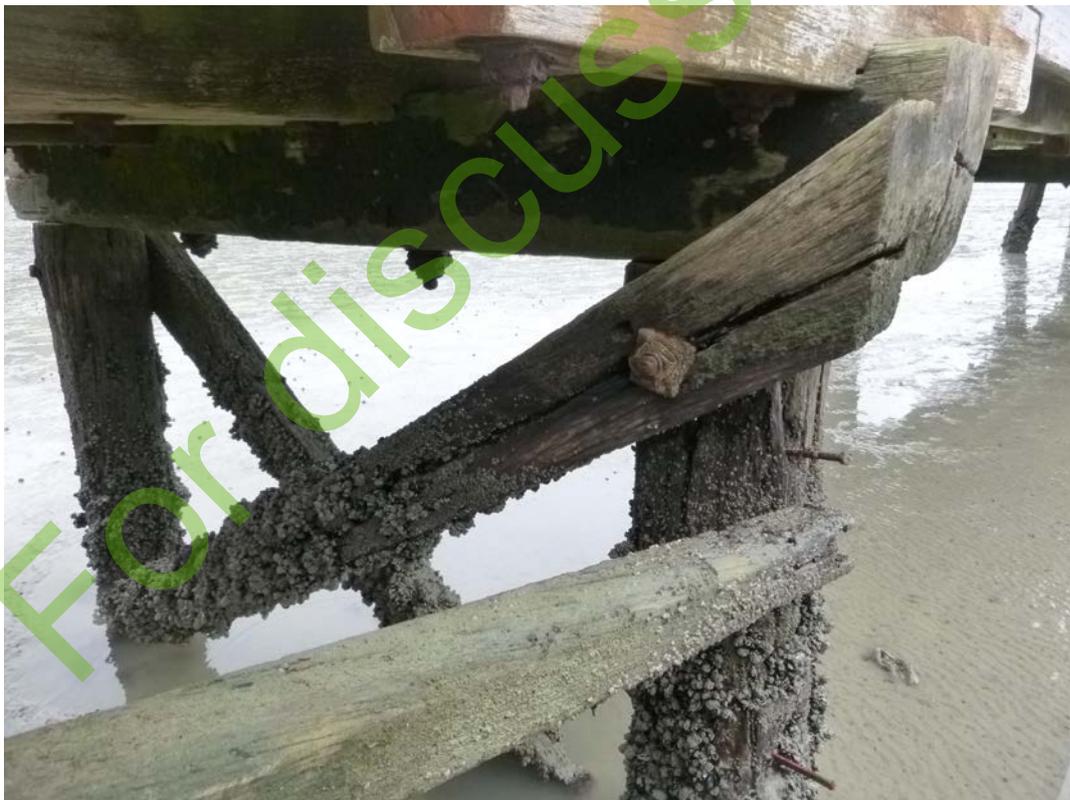
Split Brace at inner landing

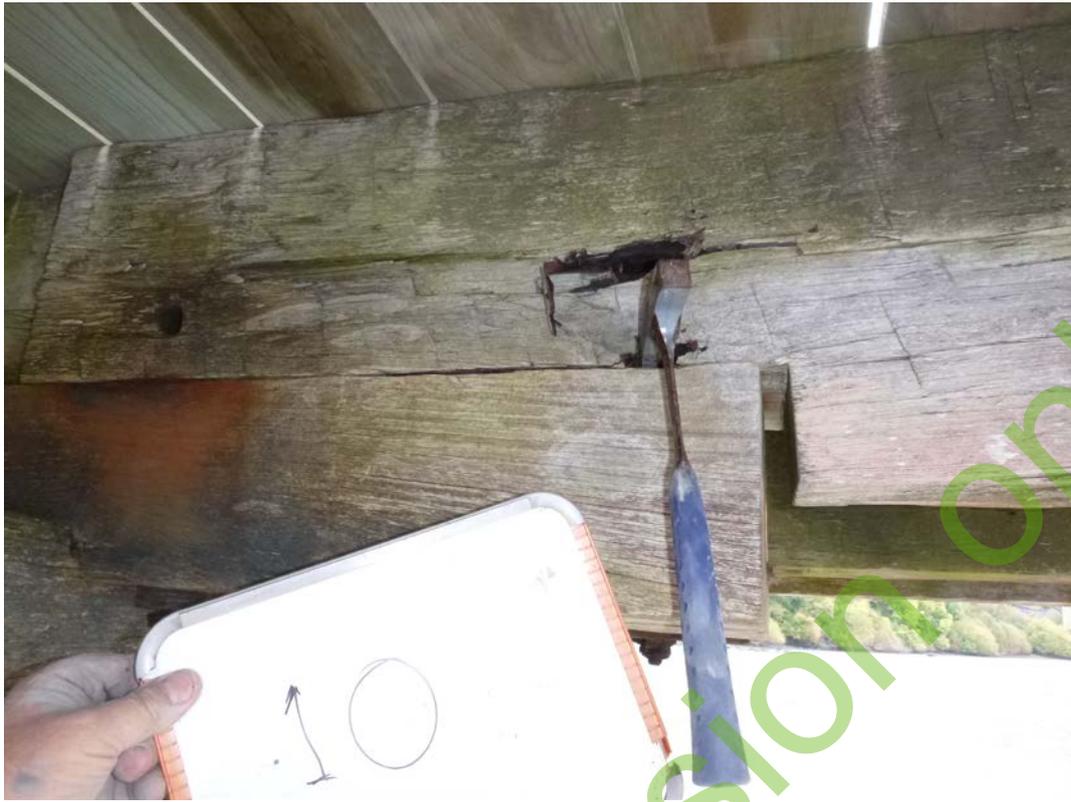
Cavity in beam at Bent 10

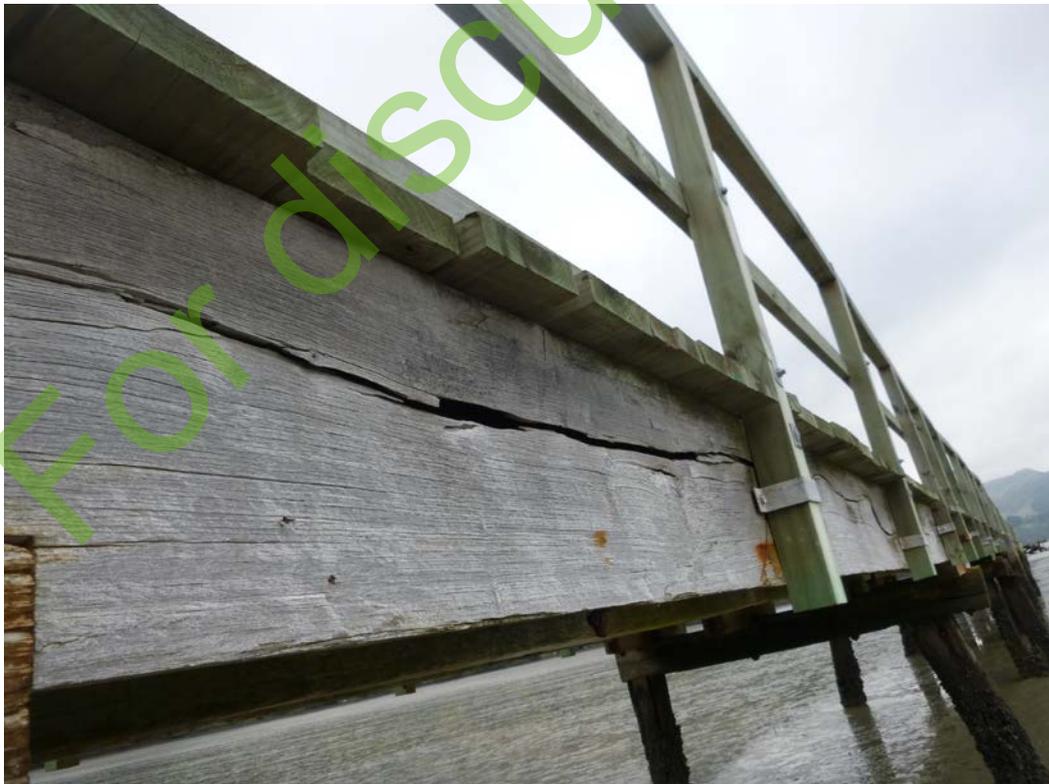
Split outer beam Span 11-12

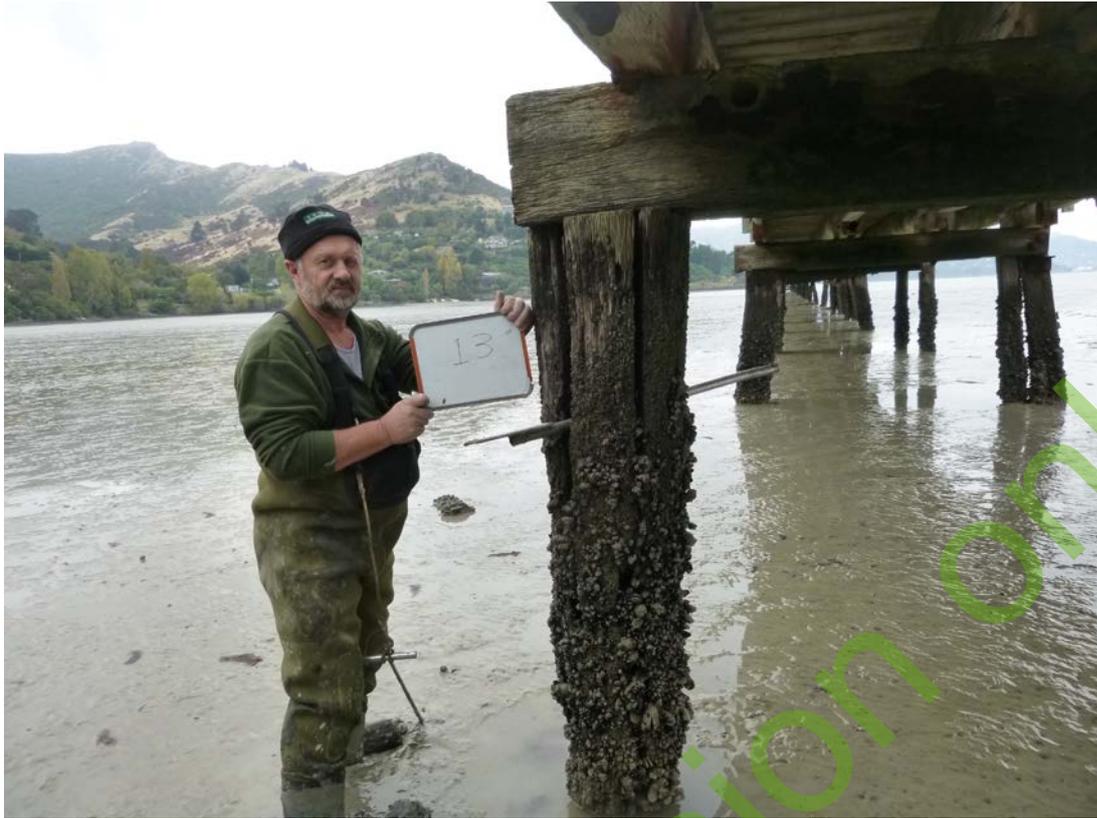
Split pile Bent 13

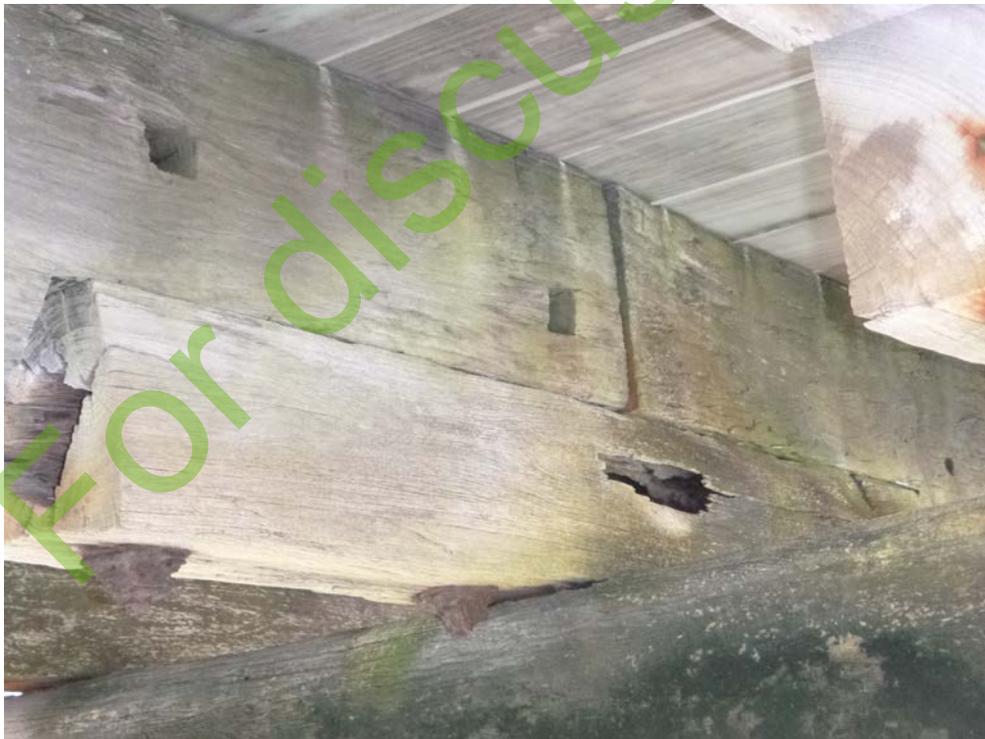
Hollow corbel Bent 14

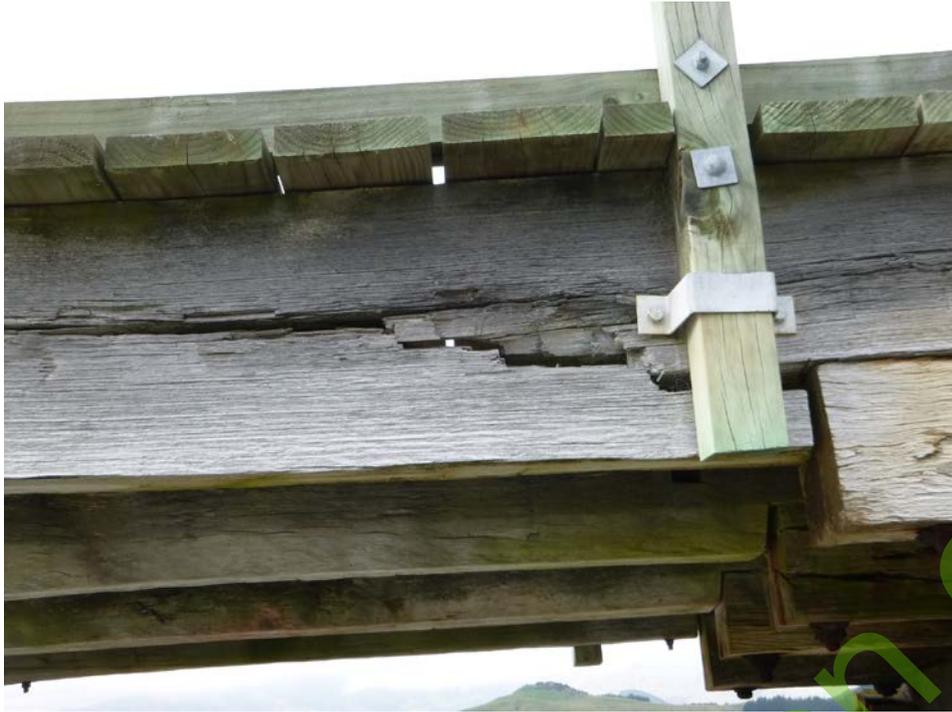
Outer beam Bent 14

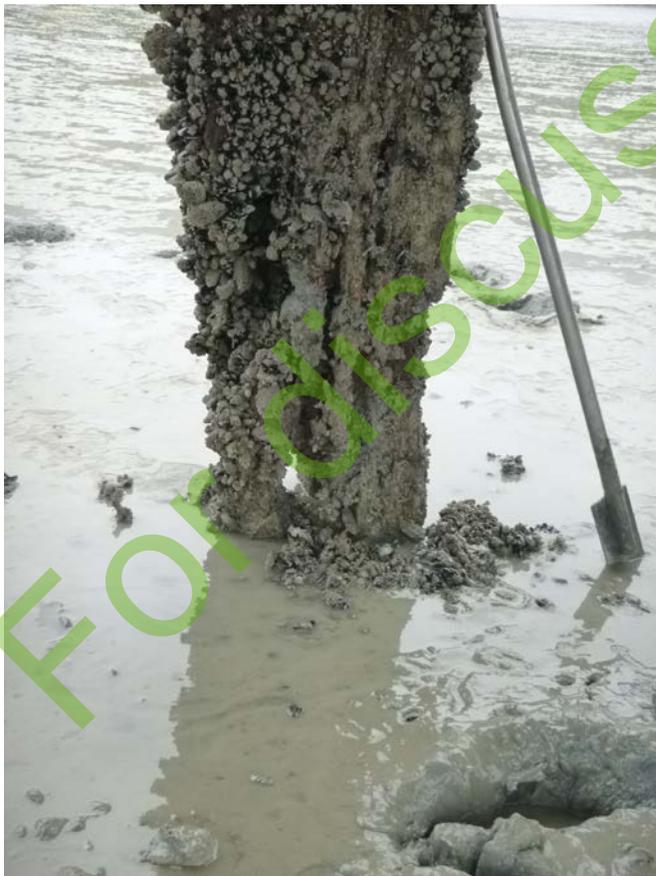
Pile at Bent 21

Bent No	S pile	Cap, bracing, corbels (on bent lines)				N pile	Deck
		Beam	Beam	Beam Drilled depth to sound timber	Beam		
		ok	beam split 100+	70	ok		
Bent 21	Original pile gone, rectangular pile bolted to cap, no bearing. 20% wasted at bed, pile has vertical split.	Cap ok				Orig Pile wasted at bed, added 250x150 supported by bolts only to cap, no bearing. Reduced pile section at bed, pile 50% wasted	
		25	100	ok	beam poor condition, split ok		
Bent 22	New 200 dia pine pile, single bolt to cap, 40mm seat only	Bent and piles leaning south	Cap ok		Orig Pile wasted at bed, added 250x150 supported by bolts only to cap, no bearing. Pile 20% wasted at bed.		
		ok	80	20	ok		
Bent 23	New 200 dia pine pile, single bolt to cap, 40mm seat only	Cap ok				Orig Pile wasted at bed, added 250x150 supported by bolts only to cap, no bearing. Pile 80% wasted at bed.	
		ok	100	100	beam poor condition ok		
Bent 24	New 200 dia pine pile, has slipped off notch and sitting on bolt below. No connection to cap, unsafe condition.	Cap ok				Pile split down centre with hollowing, u/s

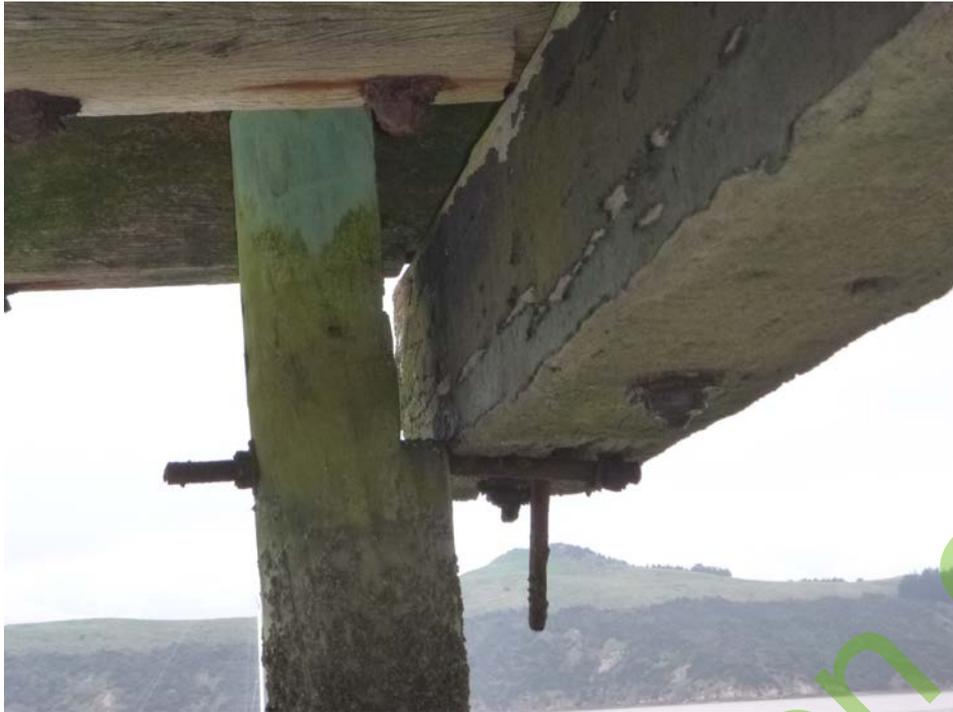
Cap precarious on new pile Bent 24

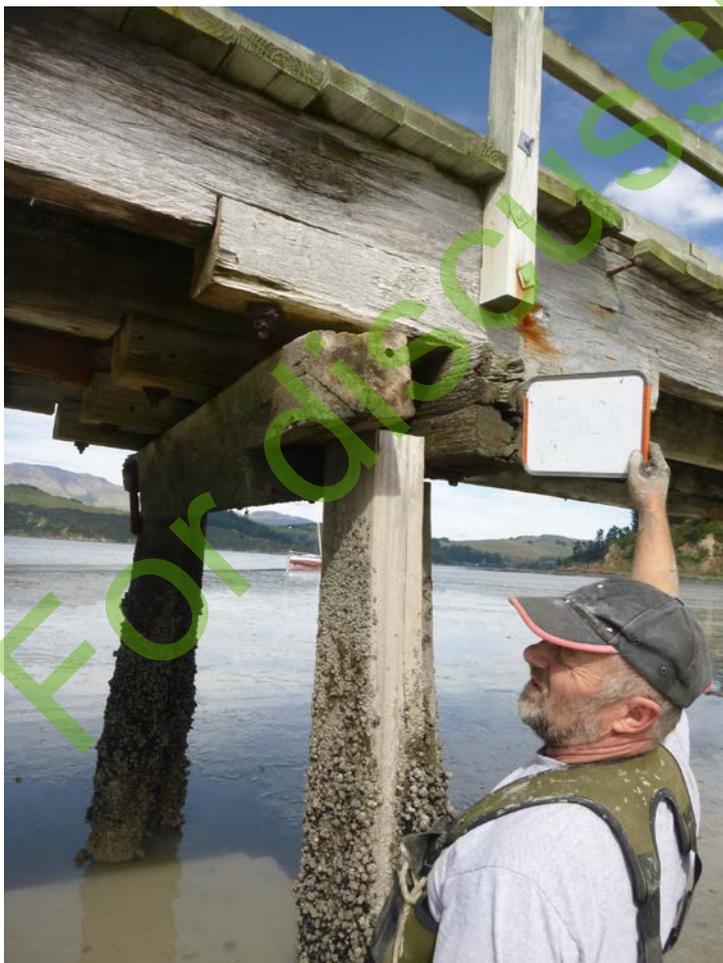
60	30	100+	20		
Bent 30	New 200 dia pine pile, single bolt to cap, 40mm seat only	Cap split s end - cap has been replaced but is not connected. Has nearly rotated off pile				Orig Pile wasted at bed, added 250x150 supported by bolts only to cap, no bearing. Pile 80% wasted at bed.	
		ok	100	100	ok		
Bent 31	New 300 dia hw pile, 80 mm check and bolt to both cap and beam	Cap ok		4 corbels to replace		New 300 dia hw pile, 80 mm check and bolt to both cap and beam	
		ok	100	new beam fitted ok	100		
Bent 32	New 200 dia pine pile, single bolt to cap, 40mm seat only	Cap ok				New rect hw pile added, no check, 1 bolt to cap 2 to old u/s pile, 50% wasted. Pile has settled.	
		ok	100+	100	100+		
Bent 33	Orig Pile split, hollow u/s	Cap ok		2 corbels to replace		New rect hw pile added, no check, 100% wasted	
		30	70	100+	70		
Bent 34	New rect hw pile added, no check, 2 bolts, ok	Cap ok		2 corbels to replace		Orig Pile 80% wasted at bed

Replacement cap bent 30 about to fall out

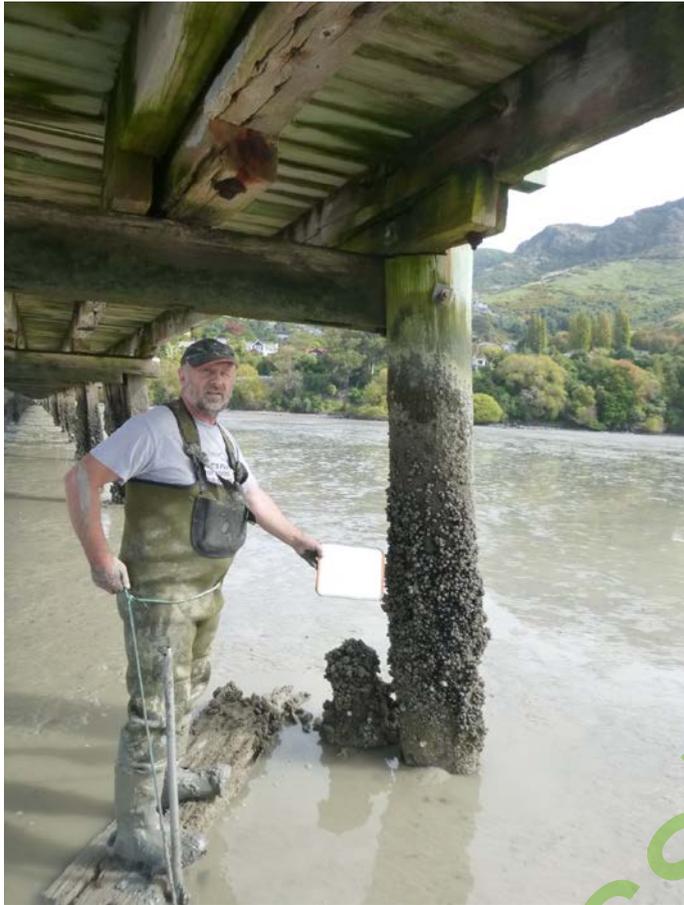
Hardwood replacement pile, checked and bolted, but only bolt supporting cap

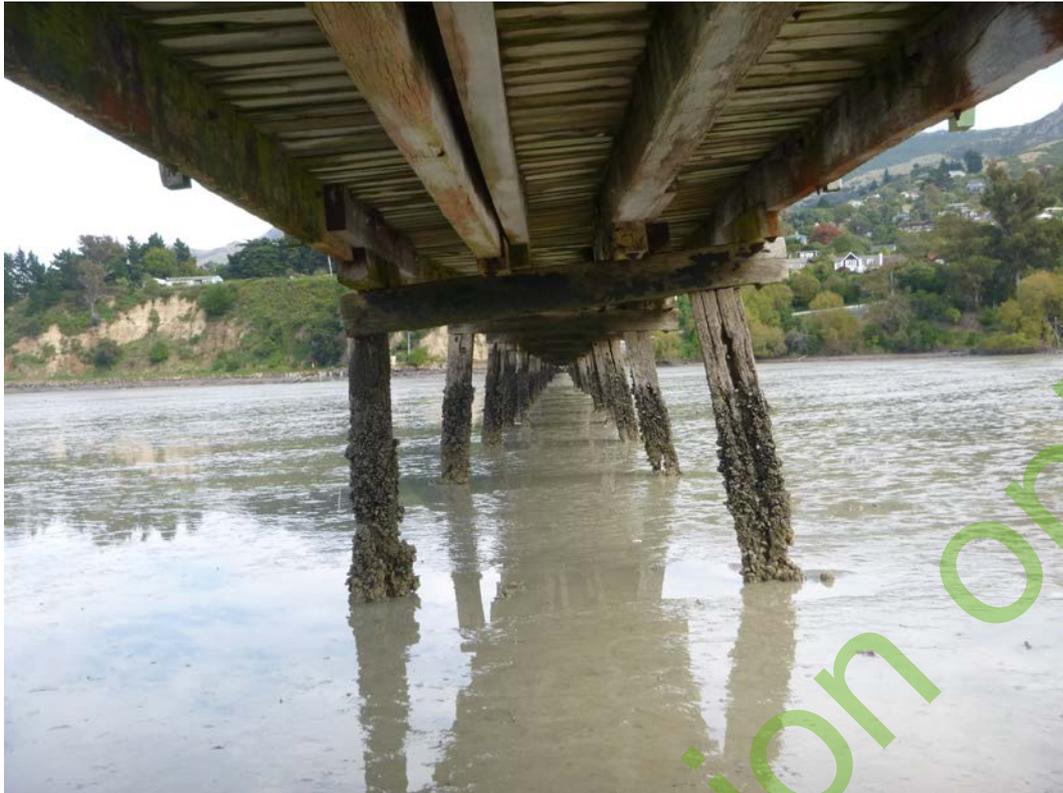
View inshore at Bent 40, settles to south

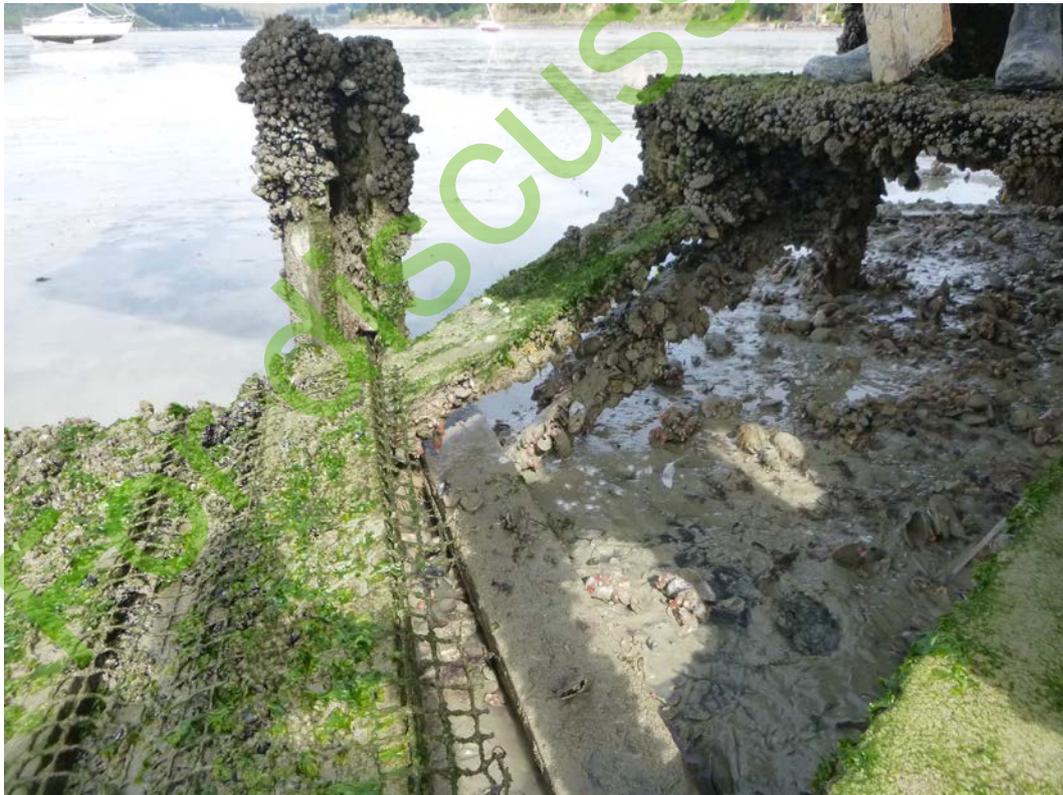
Stairs and landings their stringers and supports are in a generally poor state and require substantial replacement.

Stair stringer outer landing

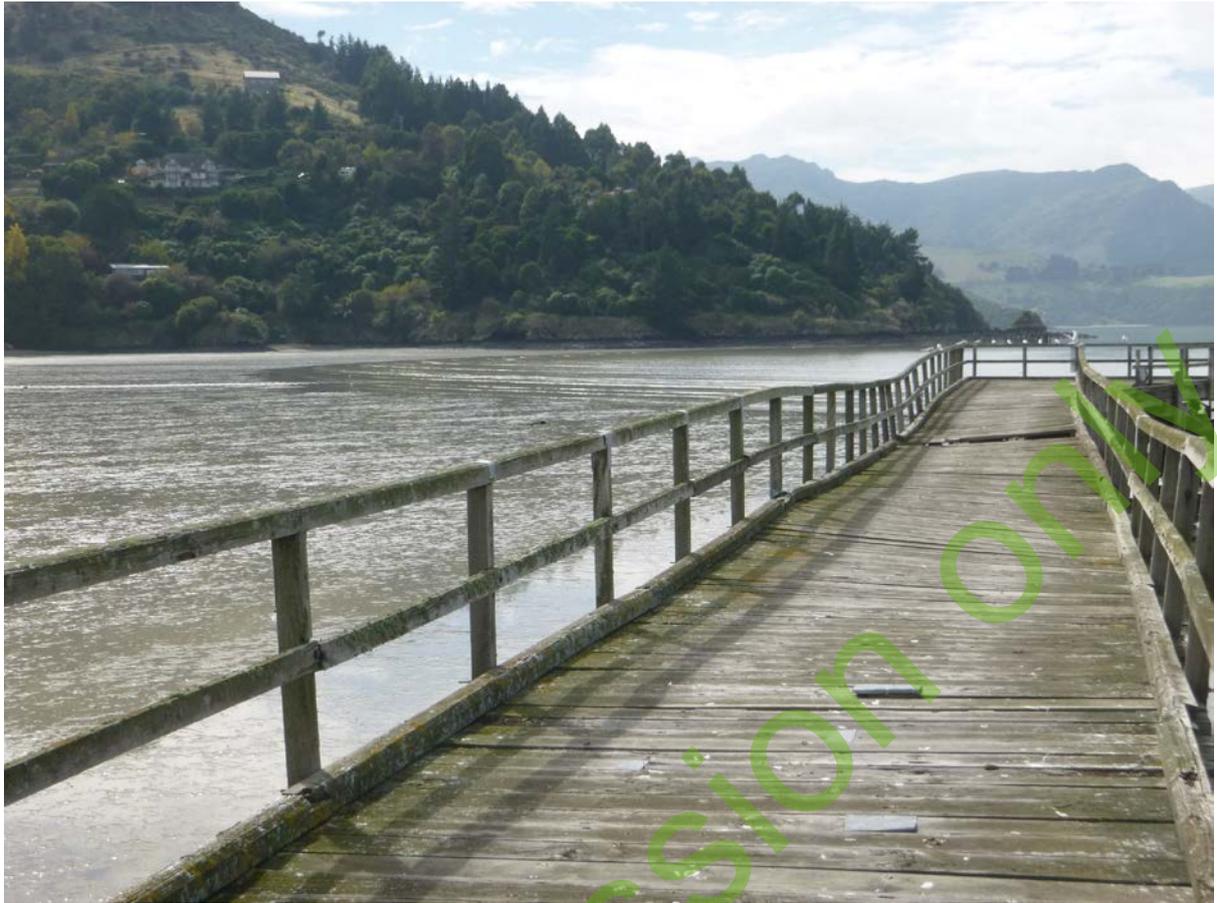
Decking and handrails were visually assessed, the inshore 185 m of deck being replaced with pine timber, the seaward section is elderly hardwood showing various degrees of aging, to the extent that there is a 2 m section missing altogether at about 260 m from the shore.

Outer deck section

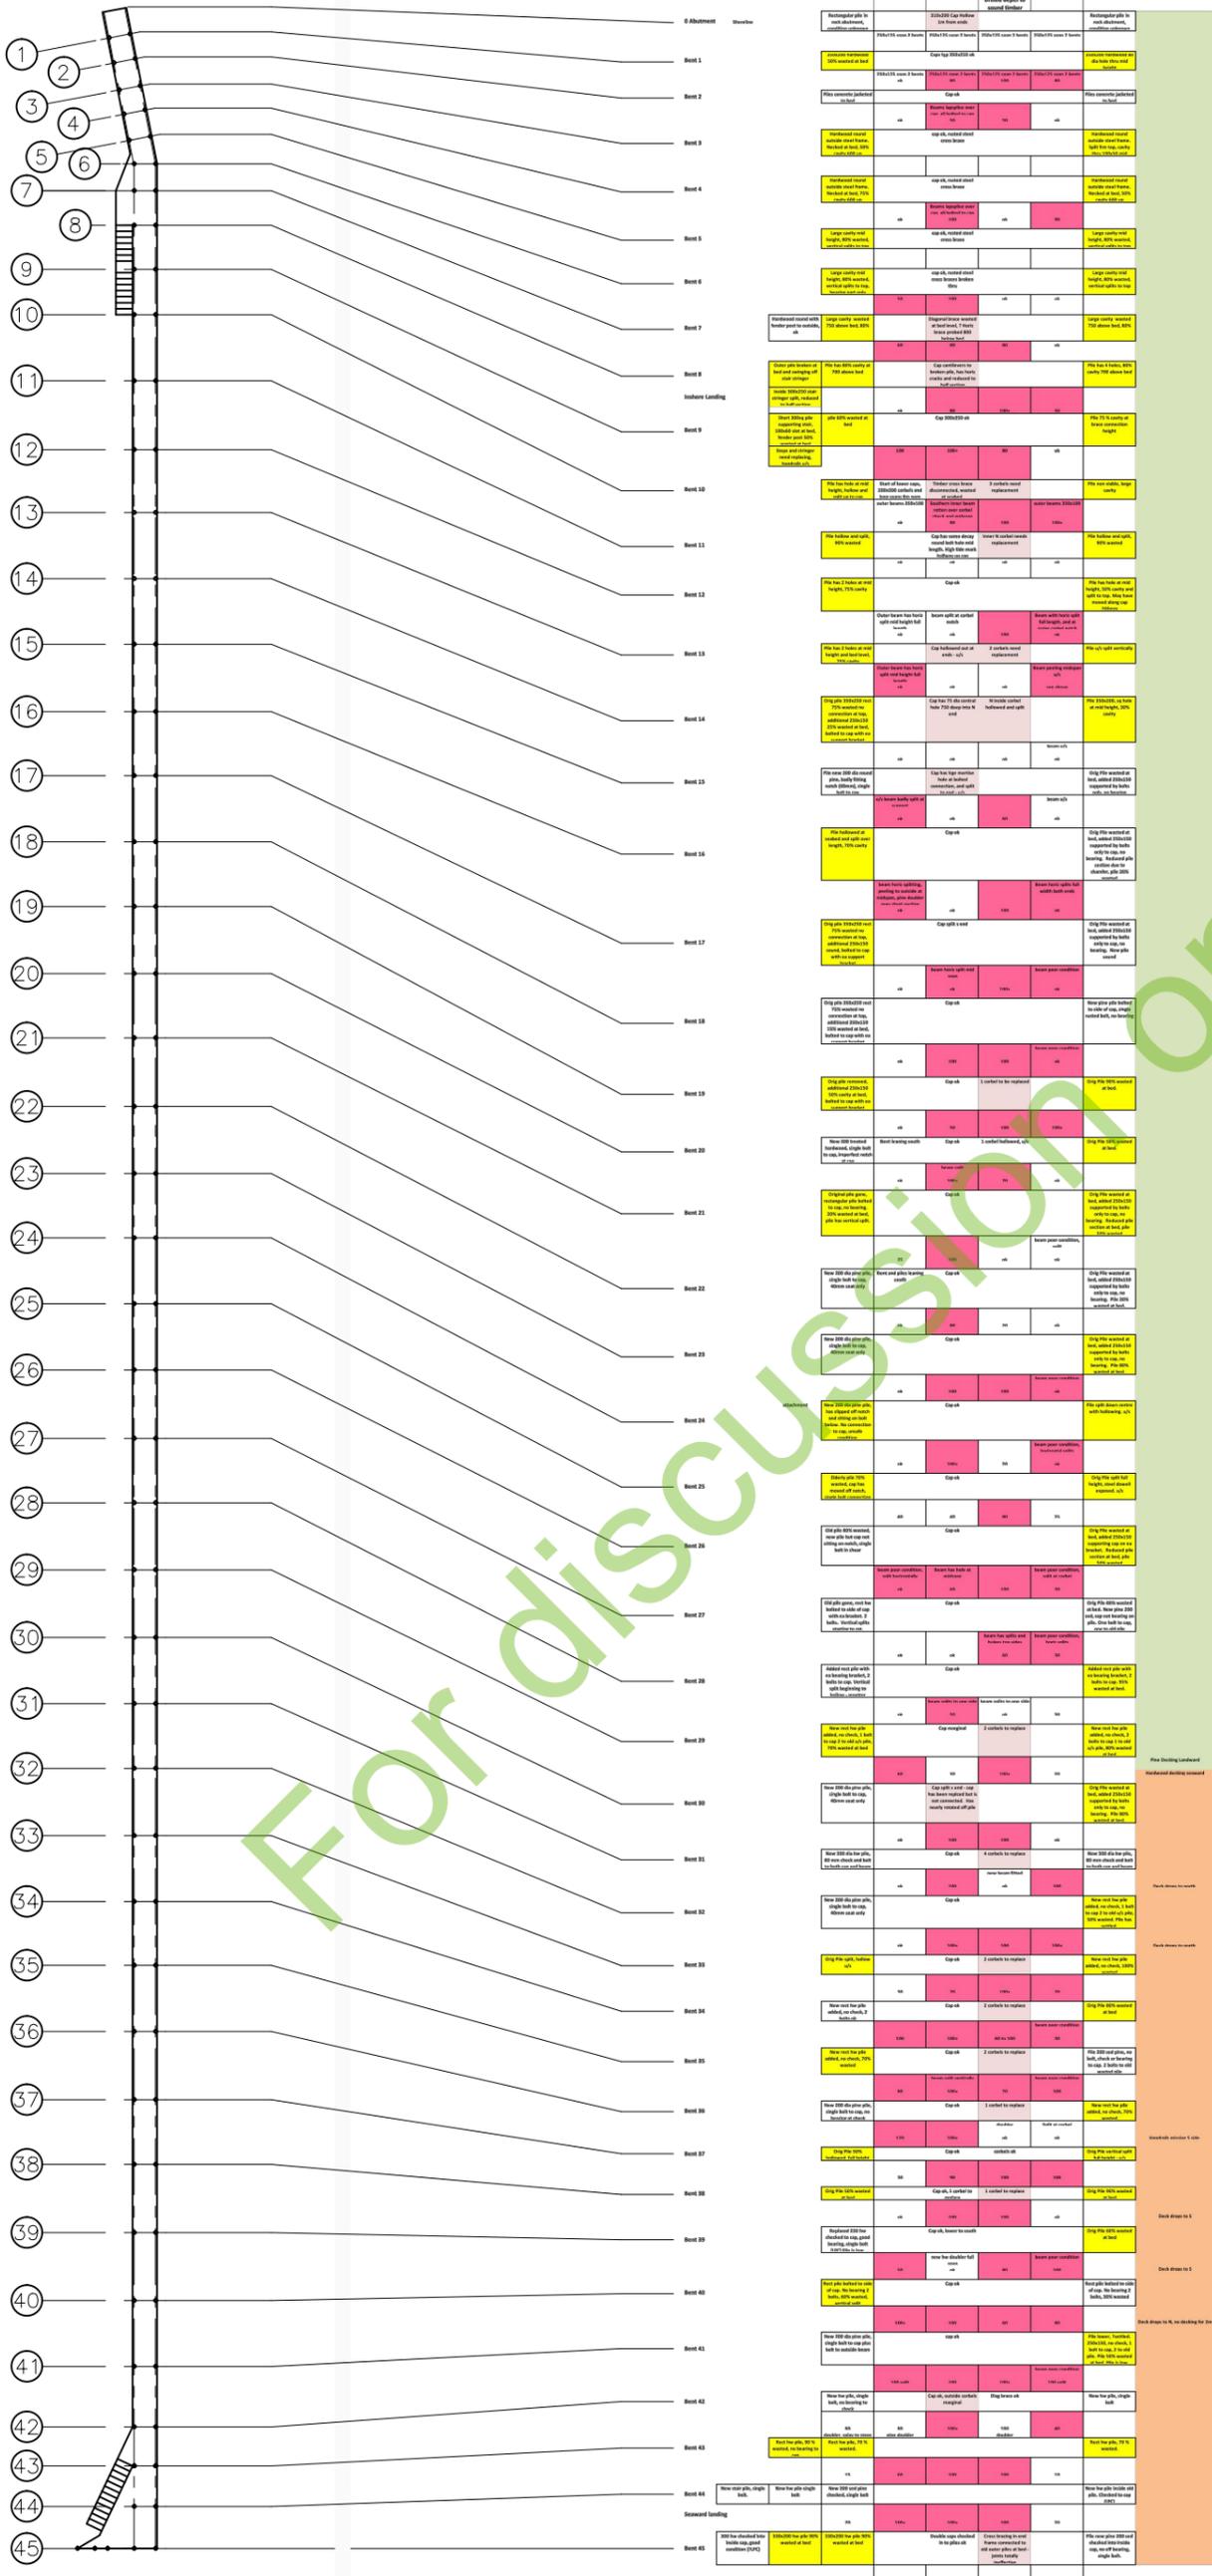
beam spans. Coloured items represent components requiring replacement as identified in the key on each sheet. The full colour coded spreadsheet is plotted with the wharf outline in the appendix to show diagrammatically the distribution of repairs proposed. Refer to the A4 prints for text detail.
